**Port of Gladstone  
Gatcombe and Golding Cutting  
Channel Duplication Project**

**Appendix E1  
Channel Duplication  
Project – Final  
Geotechnical Report**

**Port of Gladstone  
Gatcombe and Golding Cutting  
Channel Duplication Project**  
Final Geotechnical Report  
**Gladstone Ports Corporation**

19 August 2015  
Revision: 2  
Reference: 245852

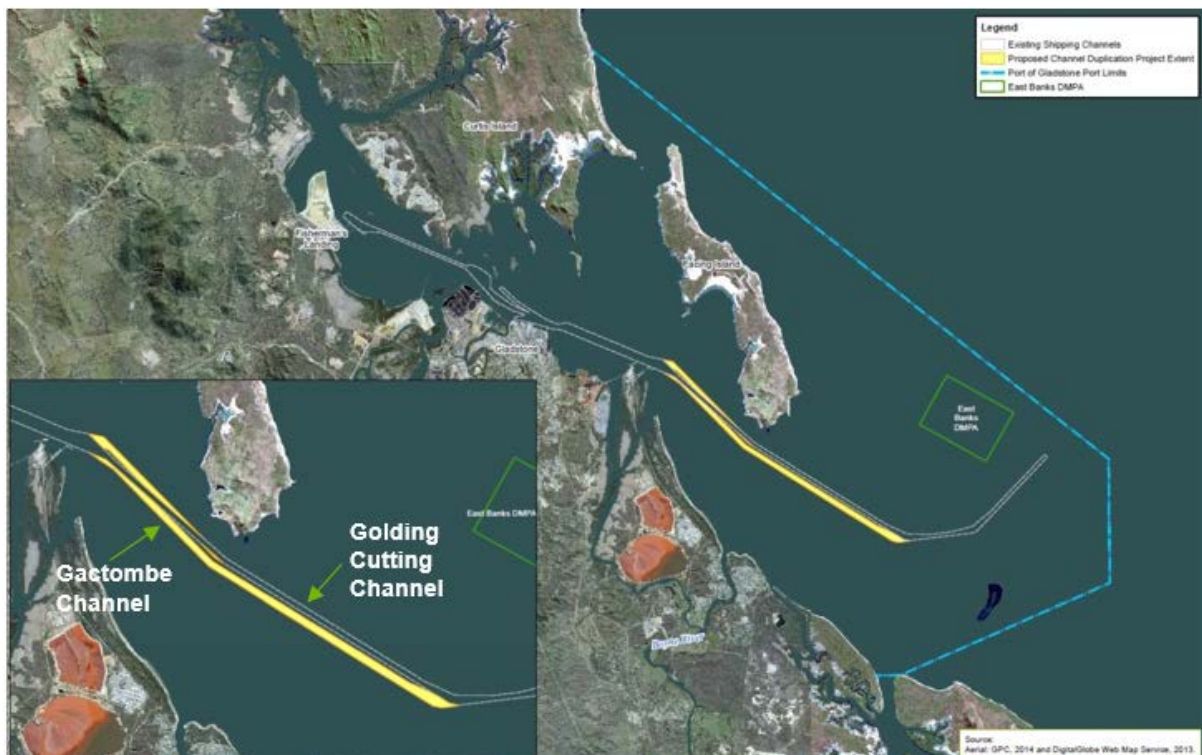
Figure 1 Location of the proposed Gatcombe and Golding Cutting duplicate channels

The duplicate channel is to be developed adjacent to the existing shipping channel, providing a two-way passage from the outer harbour, around East Banks, to the western side of Facing Island.

The proposed duplicate channel will be approximately 15.23 km long and dredging is proposed to be undertaken to an ultimate depth of -16.1 m LAT (Stage 1 to -13.5 m LAT, Stage 2 to -16.1 m LAT), with a channel width (toe to toe) of 200 m (refer Figure 1). The channel footprint is approximately 382 ha, however, due to the existing bathymetry in the Port of Gladstone, the total area requiring dredging (ie above -16.1 m LAT maximum dredge depth) is less, being 247.8 ha. The estimated volume to be dredged is 12.6 Mm<sup>3</sup>. The dredged material is proposed to be disposed in the approved dredged material placement area (DMPA).

The Port of Gladstone is situated approximately 525 km north of Brisbane. The proposed deepening and duplication of the existing Gatcombe and Golding Cutting Channels (Figure 1), is part of the GPC's strategy to facilitate the potential increase in port throughput into the future and to mitigate the risks caused by additional vessels utilising the port's shipping channels.

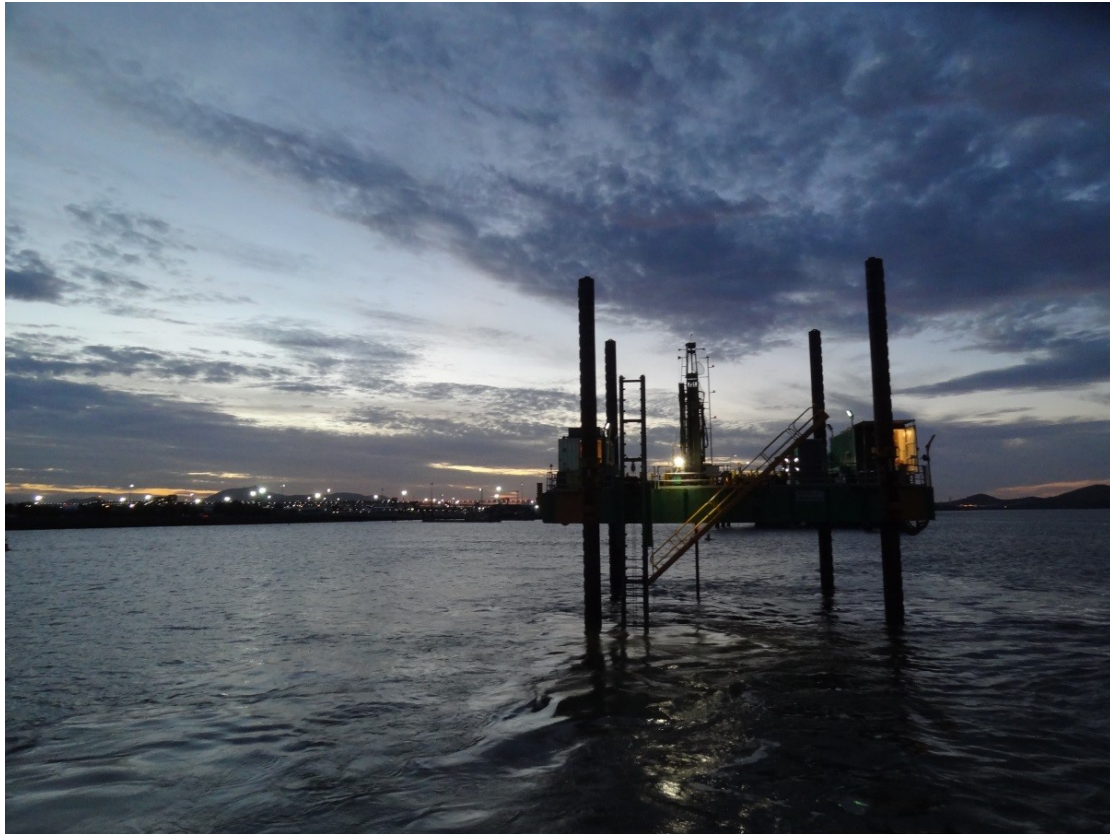
Photograph 1 View of the J&S Jack up barge "Ocean Driller II"

The J&S JUB is a modular 4 legged jack-up platform with a total deck load capacity of approximately 44 tonnes. Once in position over a borehole, the barge is jacked up to its operational height above sea level. Operational height is determined by tides and prevailing sea state conditions. In general, the barge is jacked up to have a 1 m air gap during high tide to account for waves. This relatively small air gap was chosen due to the sheltered harbour location, although the barge could be jacked higher during stormy conditions to account for prevailing sea state and surge conditions when necessary. The JUB was equipped with an Edson 3000 G rotary drilling rig, along with portable storage facilities for equipment and consumables. A photograph of the Ocean Driller 2 JUB is presented below in Photograph 1. Select photographs from the investigation, including JUB and location, are provided in Appendix D.

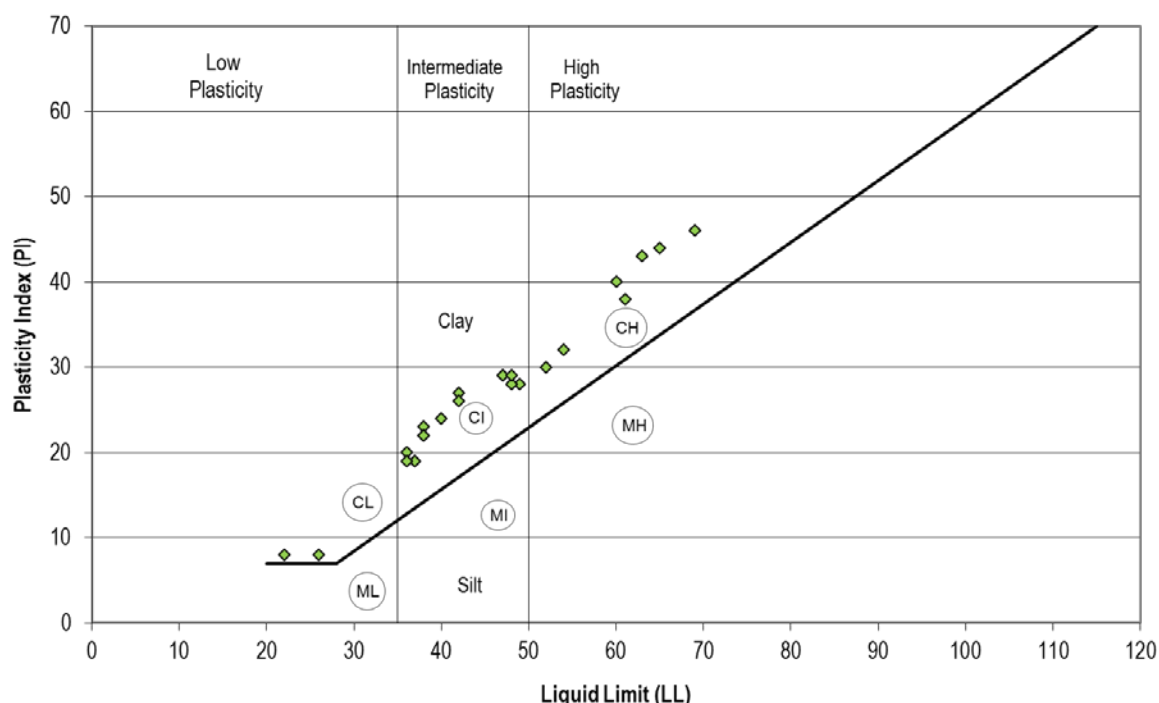
Figure 8 Combined Atterberg limits results from Gatcombe and Golding cutting channels

The Atterberg test results indicate that the majority of the cohesive material encountered within the Gatcombe and Golding Cutting Channels boreholes are composed of low to medium plasticity clays. High plasticity clay was observed in only seven samples of the 28 cohesive samples tested. These high plasticity clays observed within the proposed dredging depth and were isolated to only three boreholes (ie GG17, GG18 and GG21).

The overall plasticity of cohesive materials varied greatly between the Gatcombe and Golding Cutting Channels are to be dredged, with the Gatcombe Channel footprint having minor amounts of cohesive material which was typically low to medium plasticity. The Golding Cutting Channel area to be dredged contained a much larger percentage of cohesive material which ranged from low to high plasticity associated with "Layer 1".

Figure 8 to Figure 10 present the Atterberg results split between the two channels that require dredging, and a combined plot showing all of the results. Fewer tests were sampled for Atterberg testing in the Gatcombe Channel due to the high percentage of non-cohesive material encountered.

Layer 1	<b>Generally Cohesive:</b> This layer incorporates material recorded as principally silt (ML and MH) and clay (CL, CI and CH). From Figure 8 it can be seen that this layer located to the east of the area to be dredged and contains sand lenses.
Layer 2	<b>Generally Sand:</b> This layer underlies Layer 1 and comprises material recorded as sand (SC, SM and SP). Layer 2 is present beneath the seafloor to the west and was recorded on both the west and east sides.
Layer 3	<b>Generally Gravel:</b> Layer 3 underlies the sand layer and comprises GC and GP materials.

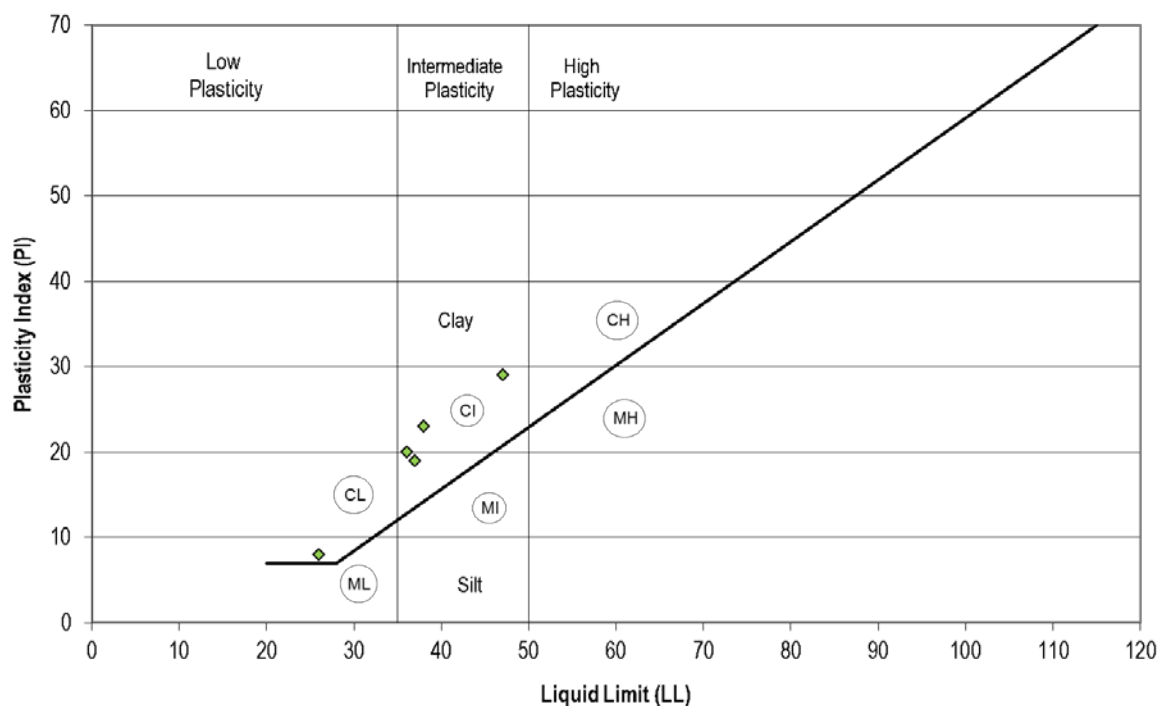
Figure 9 Atterberg results from the Gatcombe Channel

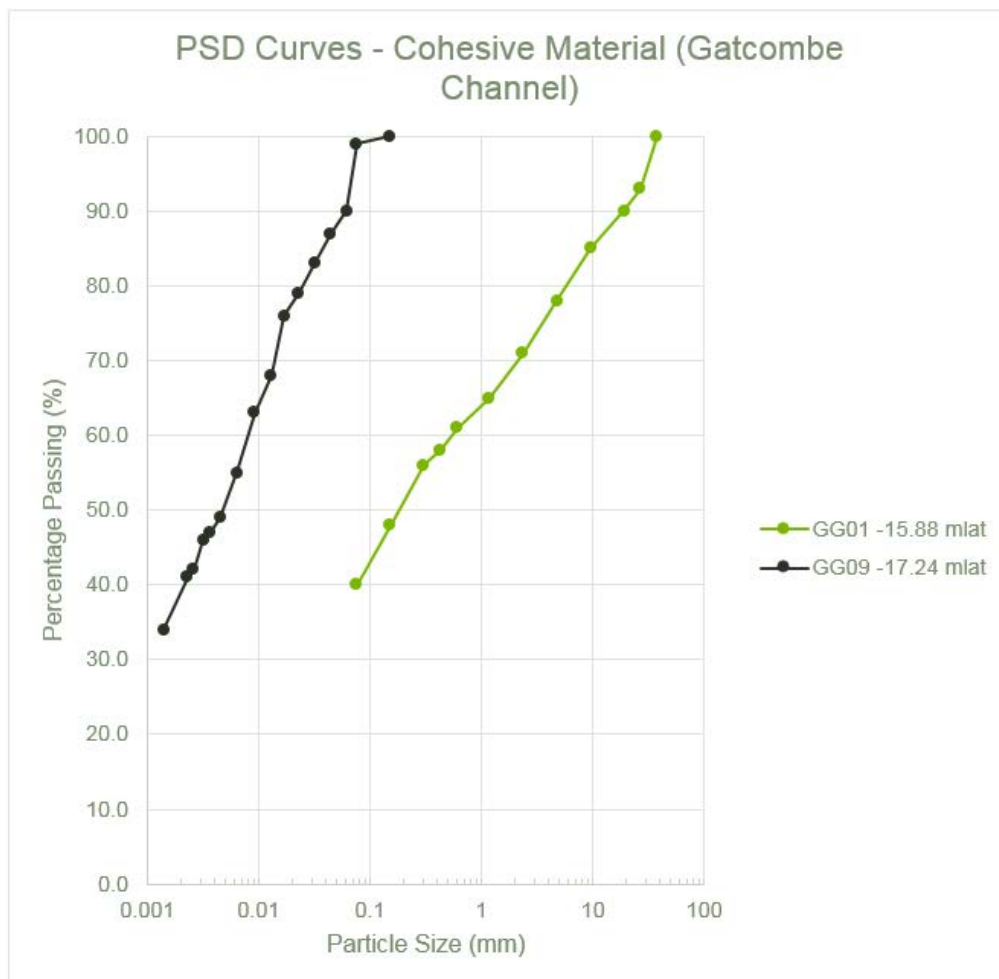
Figure 11 PSD graph of cohesive material tested within the Gatcombe Channel

Figure 11 shows the grading results from two samples of cohesive material taken from within the Gatcombe Channels. The results clearly demonstrate that clays and silts are present within the soil profile in this area.

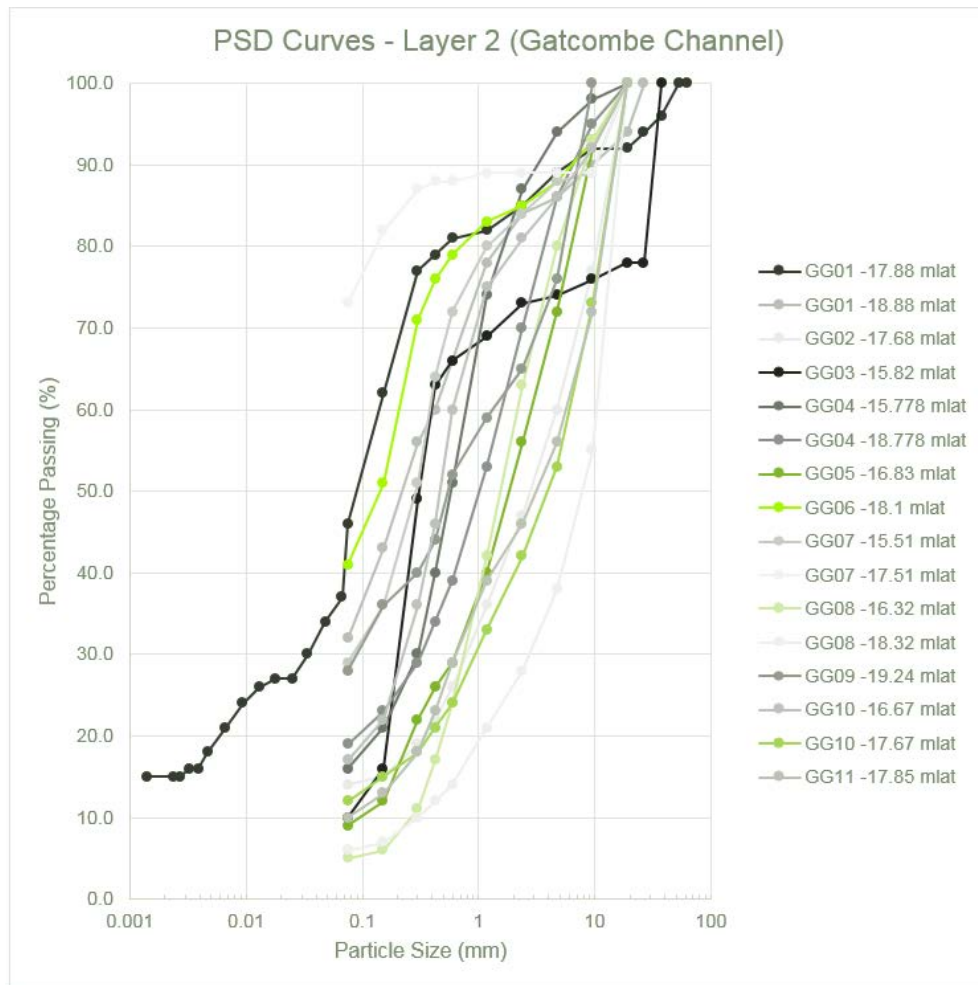
Figure 12 PSD graph showing the particle size variations in Layer 2, principally sand, within the Gatcombe Channel

For the Gatcombe Channel, the PSD results indicate that Layer 2 predominantly consists of sand, with a notable gravel content varying on average between 20 to 40% (Figure 11). Increases in gravel content are generally noted with samples recovered at a lower depth, such as at GG10 and GG11. This may be due to the material transition at the interface of Layer 3.

Some grading results, such as GG07 which is represented on Figure 12 by hollow squares, show a significant fines content. Such results demonstrate the variable nature of the deposits tested and that careful interpretation of the geological model from the borehole is required.

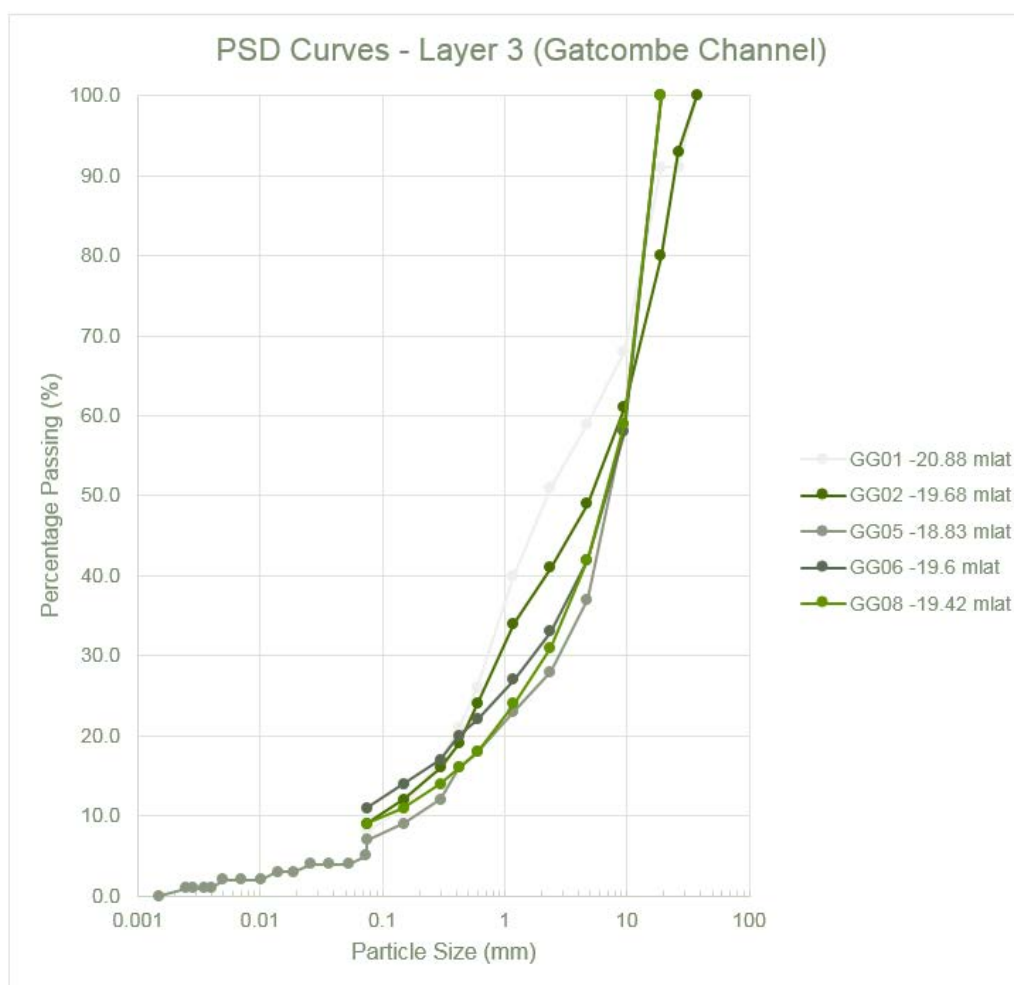
**Figure 13** PSD graph showing the particle size variations in Layer 3, principally gravel, within the Gatcombe Channel

The results of samples tested from Layer 3 in the Gatcombe Channel show reasonably consistent sandy gravel, with a high gravel content comprising of approximately 50 – 70% of the recovered material (Figure 13).

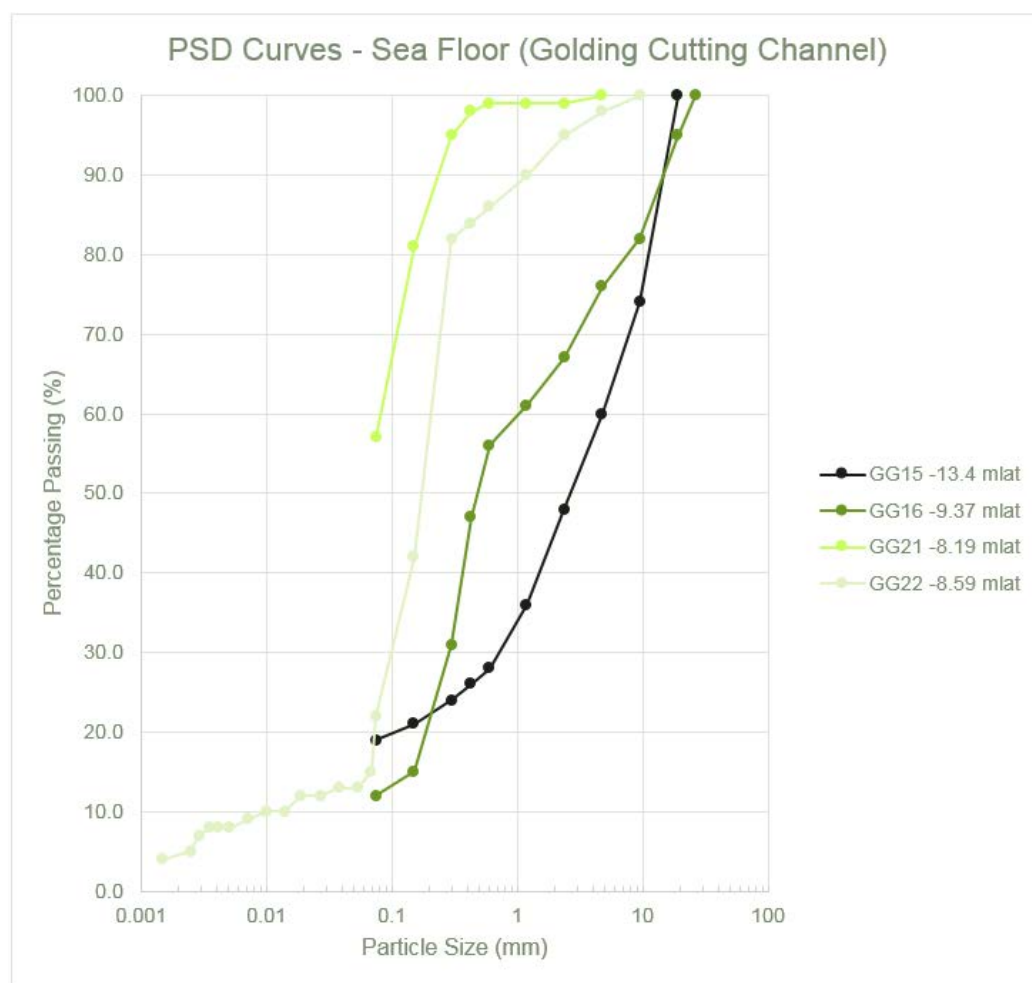
**Figure 15** PSD graph showing the particle distribution curves for the seafloor material within the Golding Cutting Channel

For both the Gatcombe and Golding Cutting Channels, the PSD results attributed to the surficial seafloor layer (Figure 15) and Layer 1 (Figure 16) show the greatest variation. It is expected this is in part due to sampling bias, with samples collected in the cohesive materials undergoing Atterberg Limits testing, as opposed to PSD testing. Also, increased diversity in material type may be found in the upper layers due to tidal action and the ongoing movement of surficial sediments.

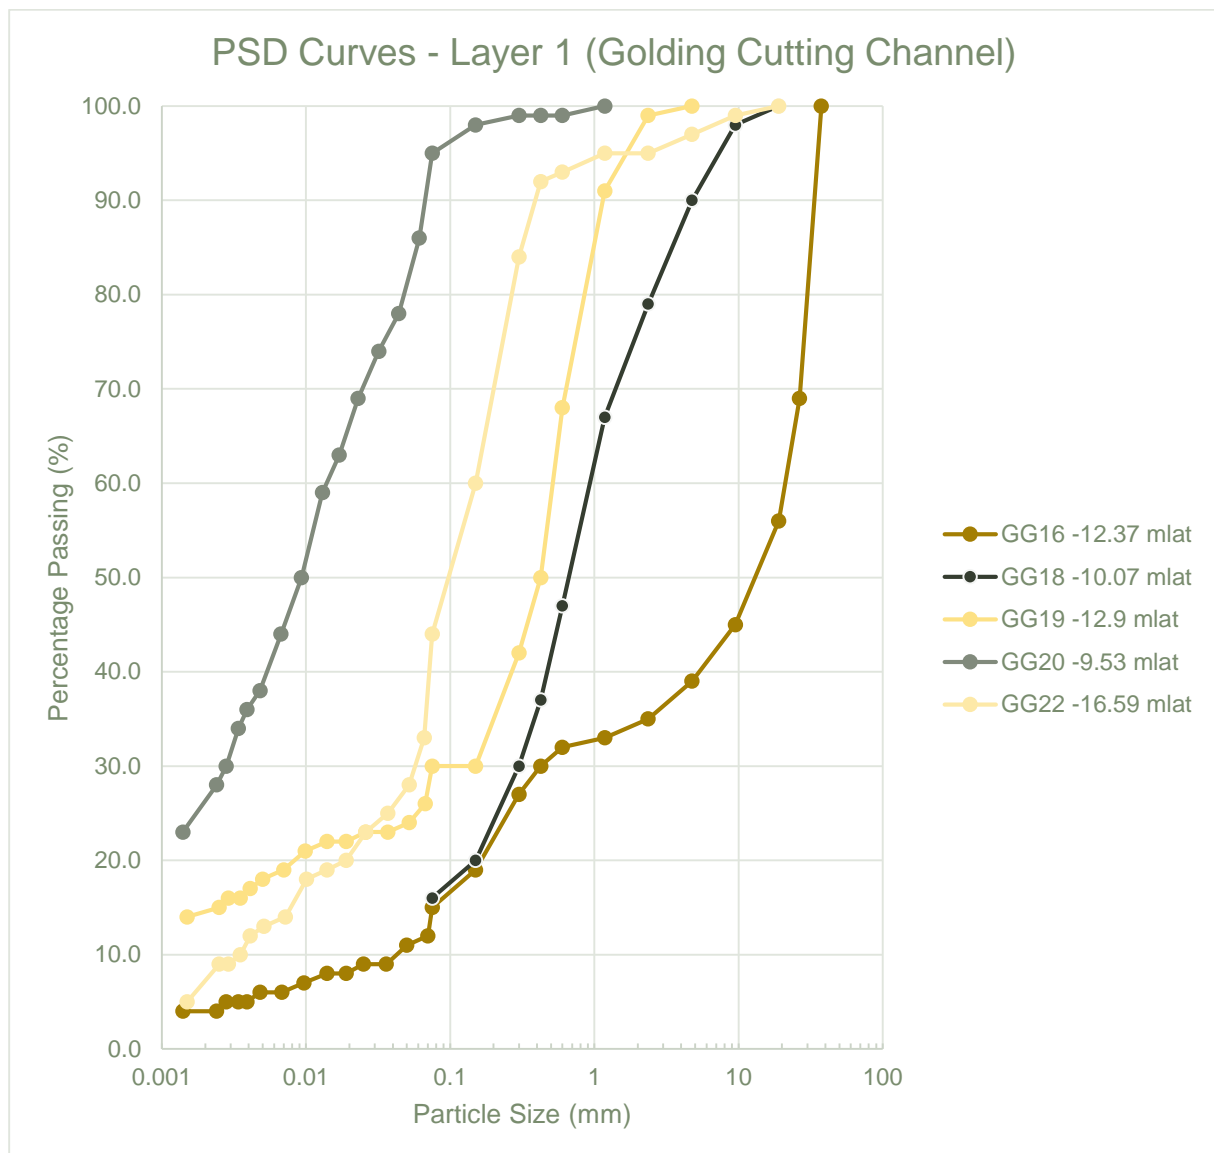
**Figure 16** PSD graph showing the particle distribution curves for Layer 1 within the Golding Cutting Channel

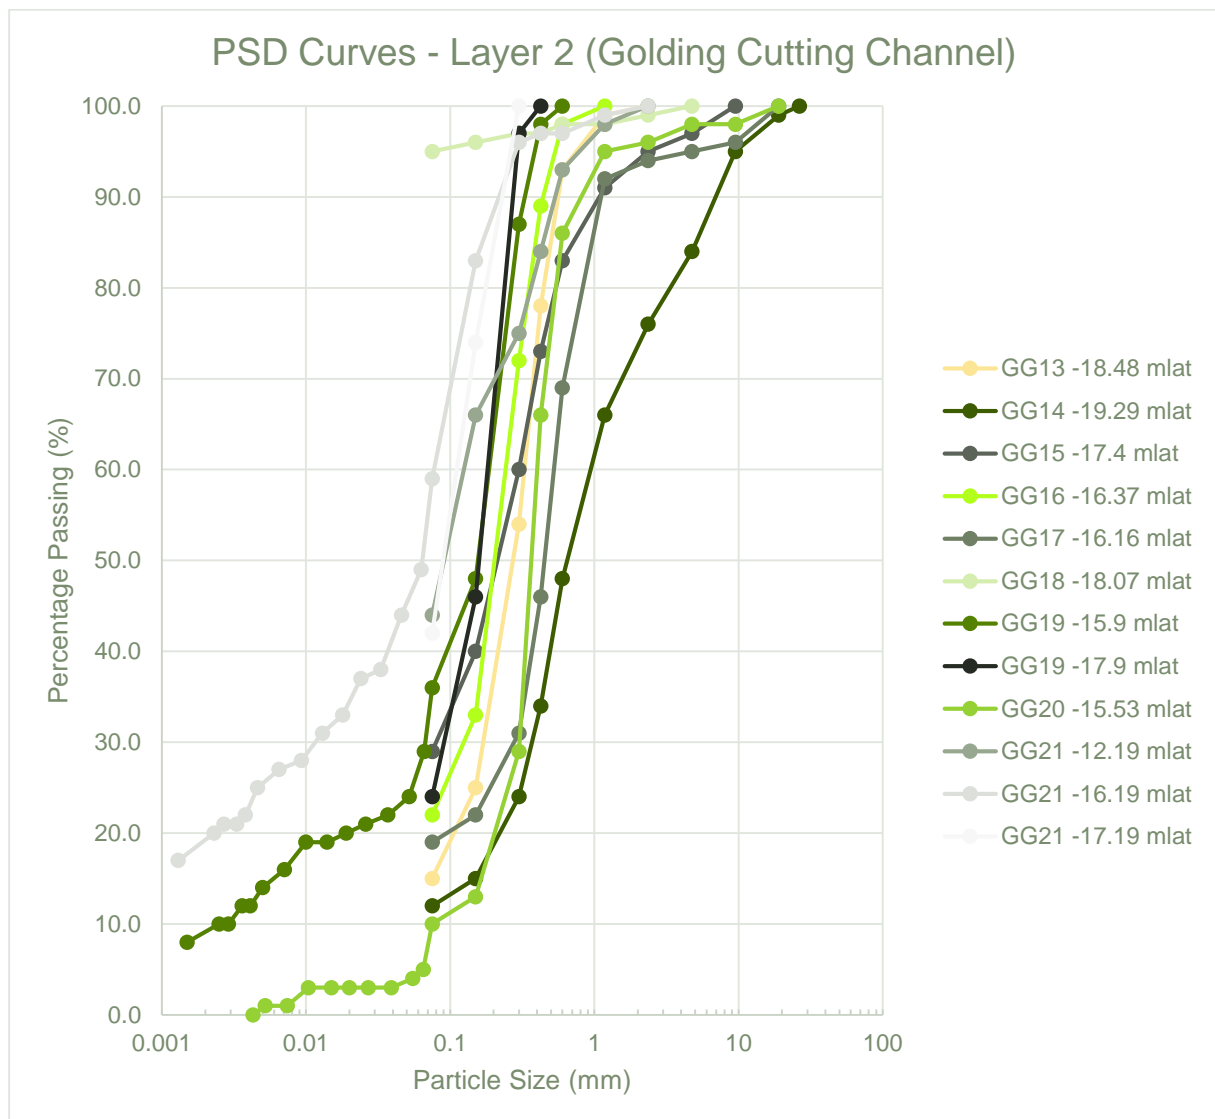
**Figure 17** PSD graph showing the particle distribution curves for Layer 2 within the Golding Cutting Channel

In terms of the Golding Cutting Channel, the Layer 2 PSD graphs prove that in general this material comprises sand (Figure 17). The gravel content in the Golding Cutting Channel is, however, found to be reduced when compared to the results from the Gatcombe Channel.

A notable outlier in the Golding Layer 2 results is observed at GG18 (-18.07 m LAT). This is due to a zone of sandy clay observed within the stratigraphy at that location.

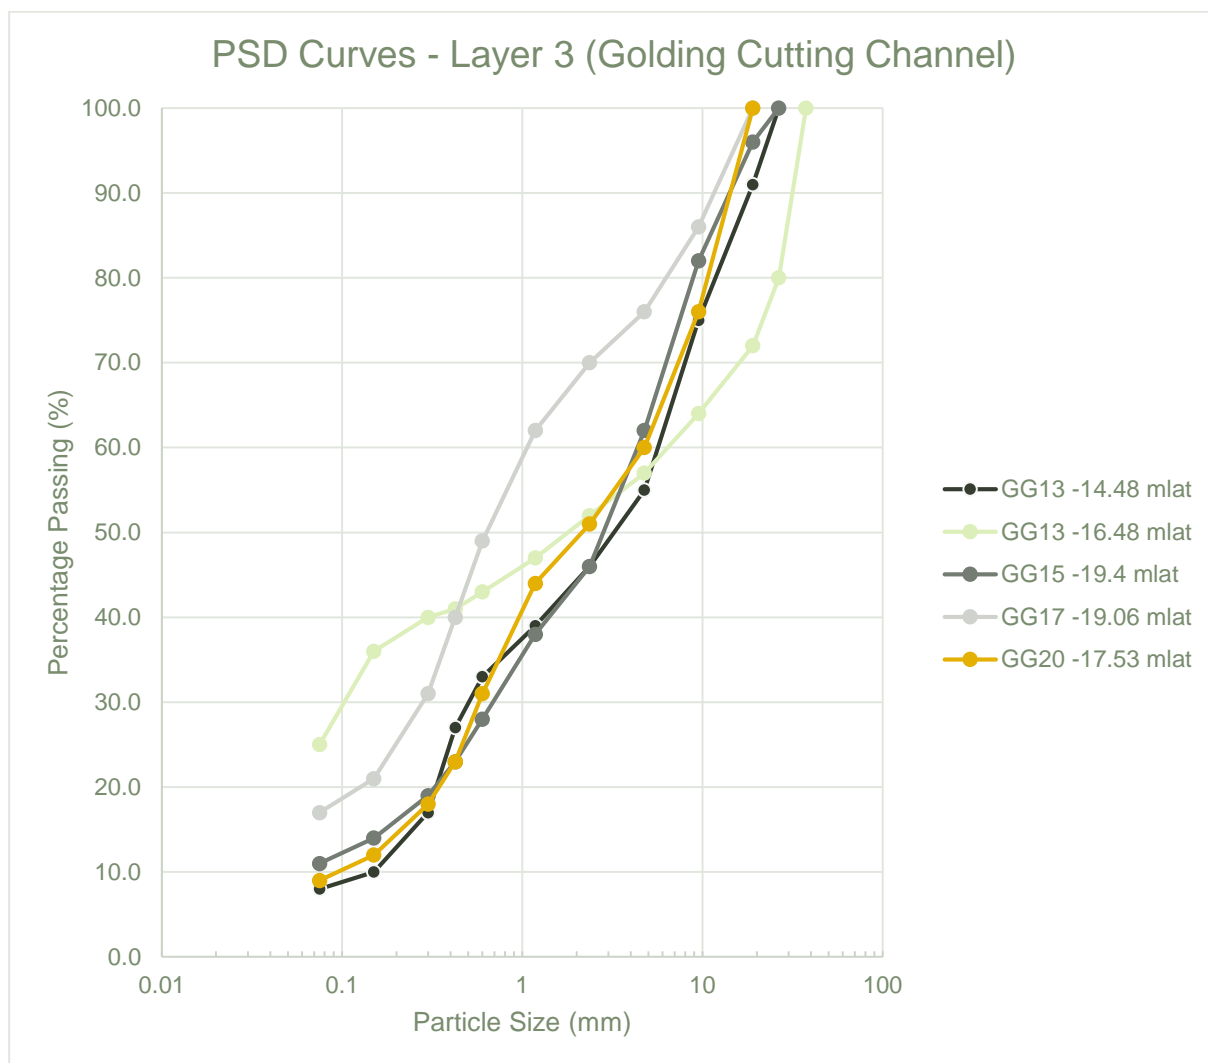
**Figure 18** PSD graph showing the particle distribution curves for Layer 3 within the Golding Cutting Channel

Layer 3 within the Golding Cutting Channel, while still considered to be predominantly gravel, also demonstrates a similar reduction in gravel content and a higher percentage of both sand and fines (Figure 18).

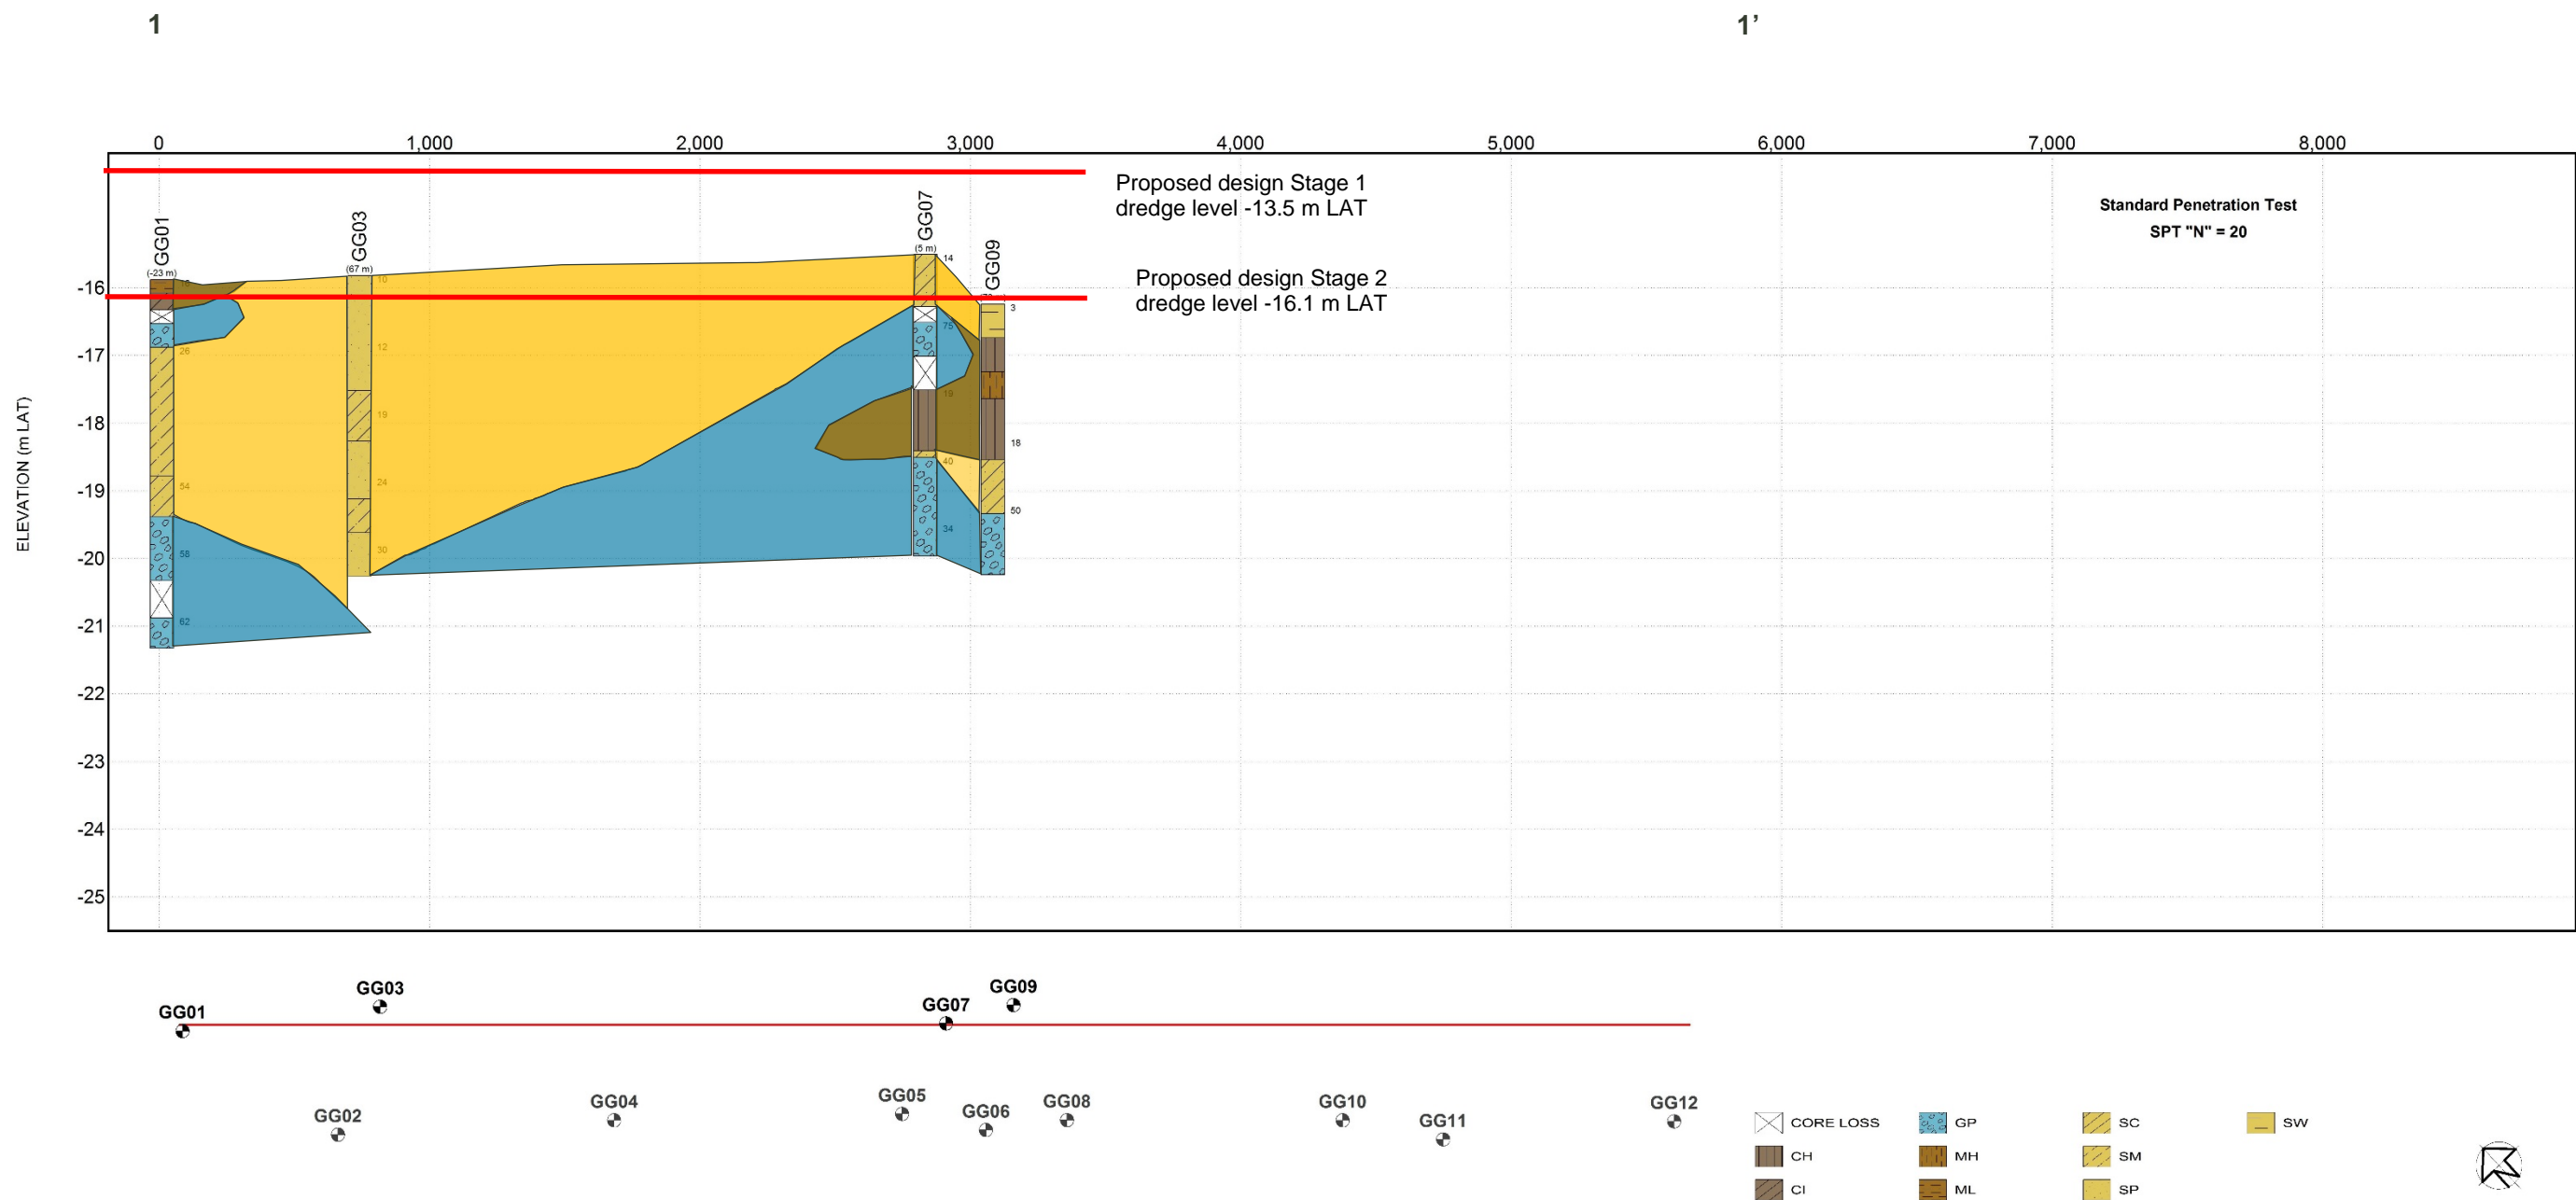
Figure 25 Sketch of the interpreted geological section for the Gatcombe Channel (north) (NTS)

The north section includes four boreholes (GG01, GG03, GG07 and GG09) and demonstrates the innate geological variability with respect to clear stratum delineation based on soil type as described earlier. A different soil type was recorded on the seafloor at each borehole location, though the principal constituent of the seafloor in this area was recorded as sand. High plasticity clay and silt was recorded in both GG07 and GG09 from approximately -16.8 m LAT, but these materials were not recorded in GG01 and GG03. Principally, gravelly soil was recorded at the base of the boreholes from -18 m LAT, except for borehole GG03 which comprised sand and clayey sand from seafloor to the base of the borehole at -20.2 m LAT.

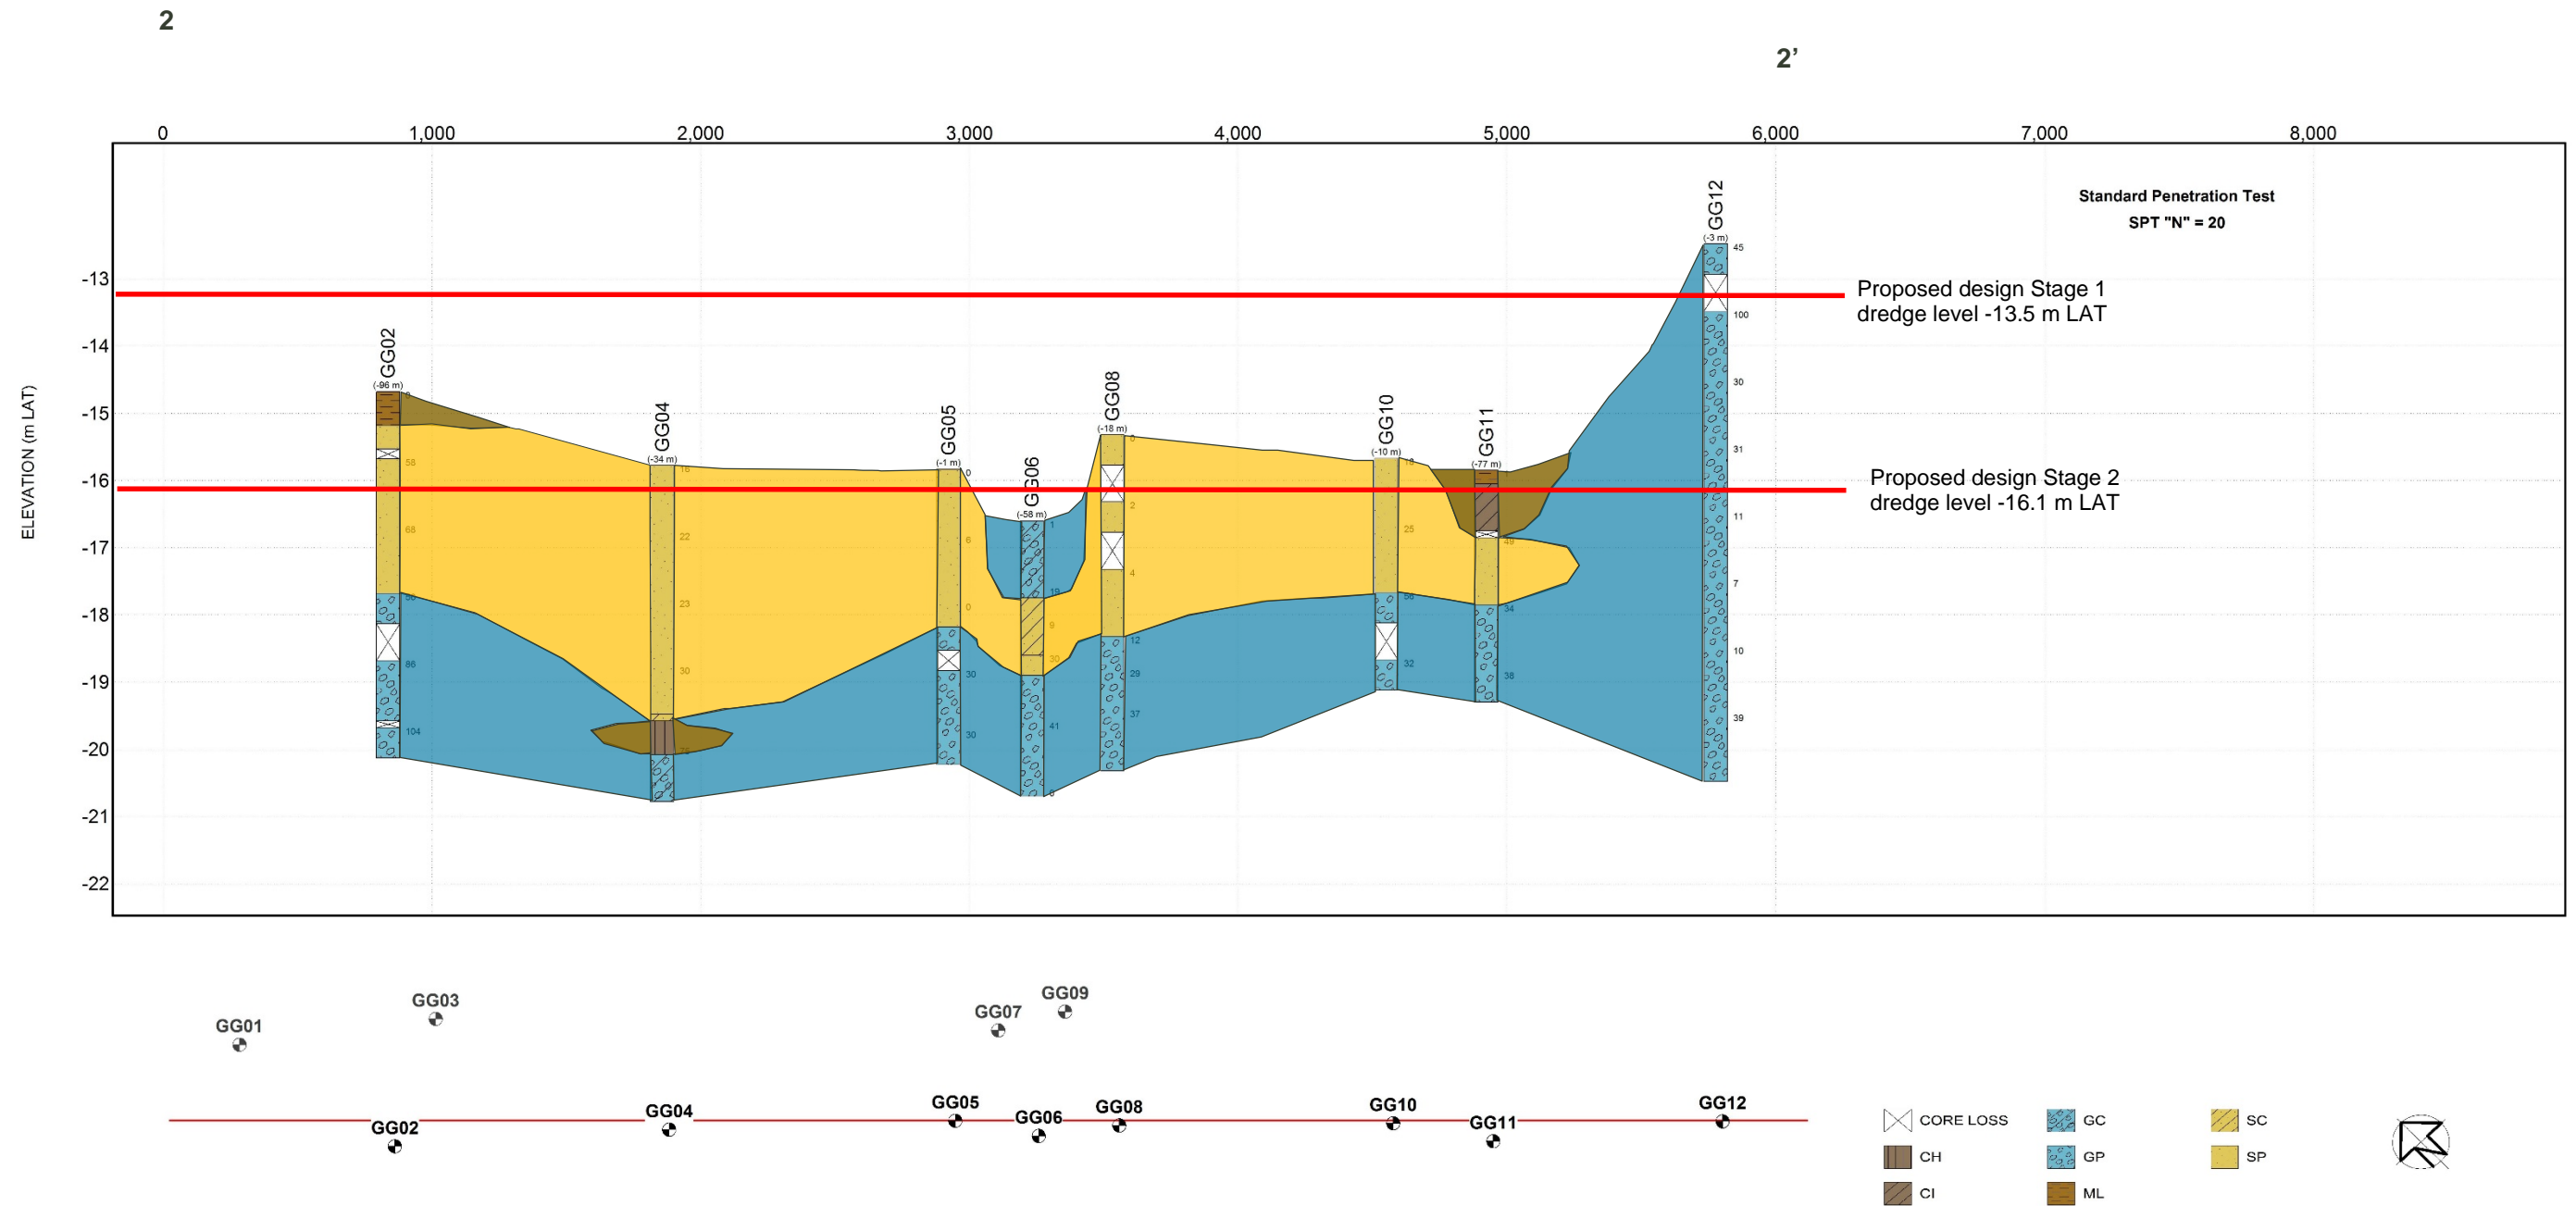
Figure 26 Sketch of the interpreted geological section for Gatcombe Channel (south) (NTS)

Similar to the north section, the south section does not provide clear stratum delineation based on soil type (Figure 25). However it is considered that the eight boreholes (GG02, GG04, GG05, GG06, GG08, GG10, GG11 and GG12) do provide *some* pattern with respect to layering. Typically the sea floor material comprises poorly graded sand, though low plasticity silt was recorded at borehole location GG02 and GG11 and poorly graded gravel recorded at GG06 and GG12. Beneath this top layer, variably dense (loose to very dense), poorly graded sand dominates the profile to a maximum

depth of -19.6 m LAT. This sand layer is typically underlain by medium dense to very dense, clayey and poorly graded gravel. Exceptions to this were observed within borehole GG04 where high plasticity clay was recorded circa -19 m LAT between the sand and the gravel, and within borehole GG12 which encountered only loose to very dense poorly graded gravel from to sea bed (-18 m LAT) to borehole termination (circa -20.5 m LAT).
